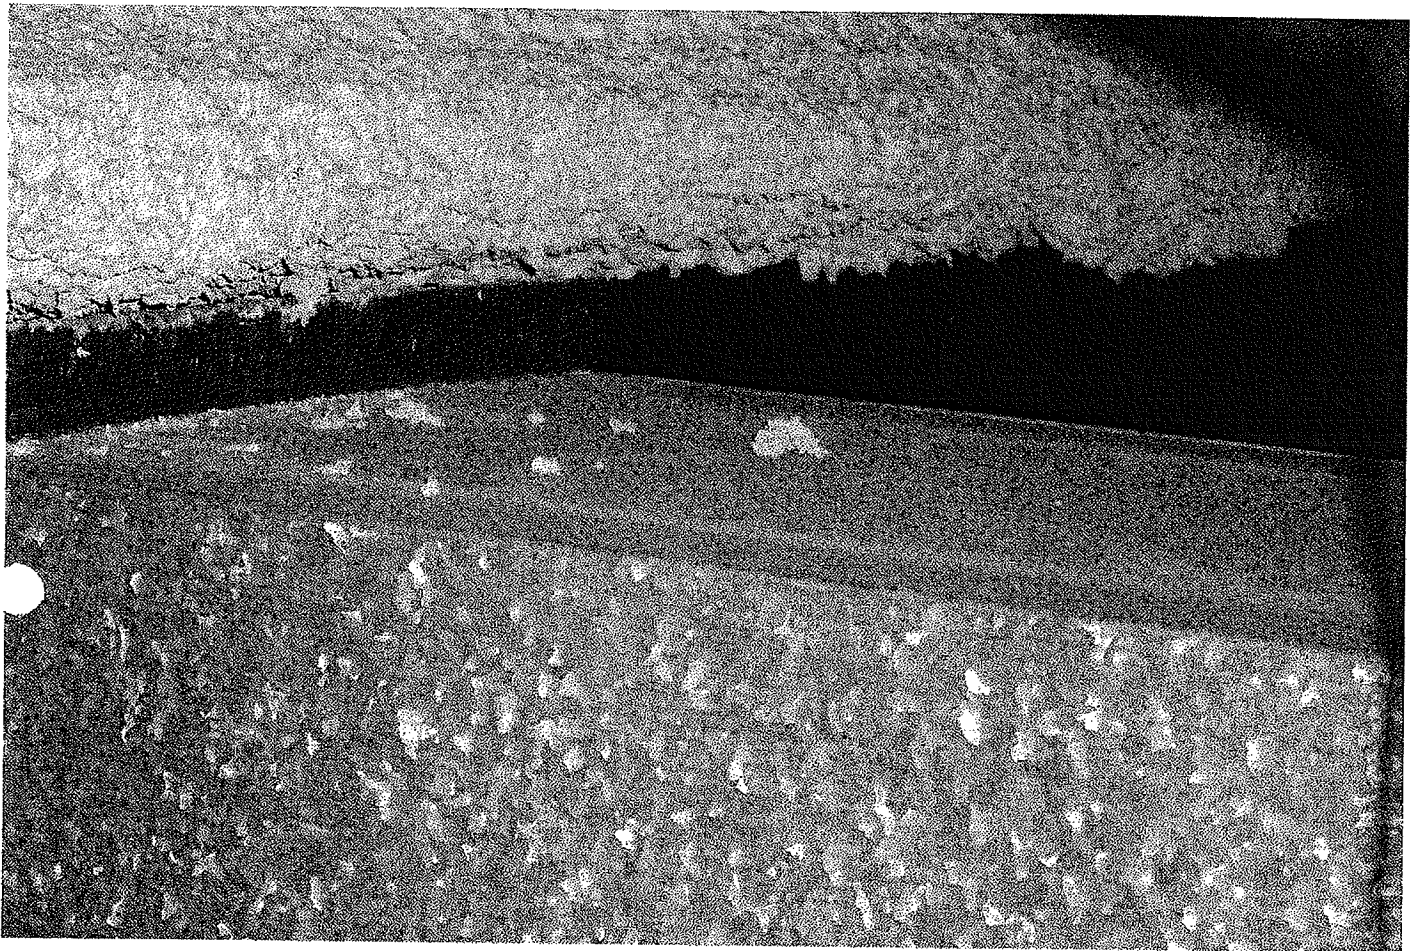
26. 24th floor, adjacent to room W2412B - View of dislodged fireproofing debris on top of metal HVAC duct

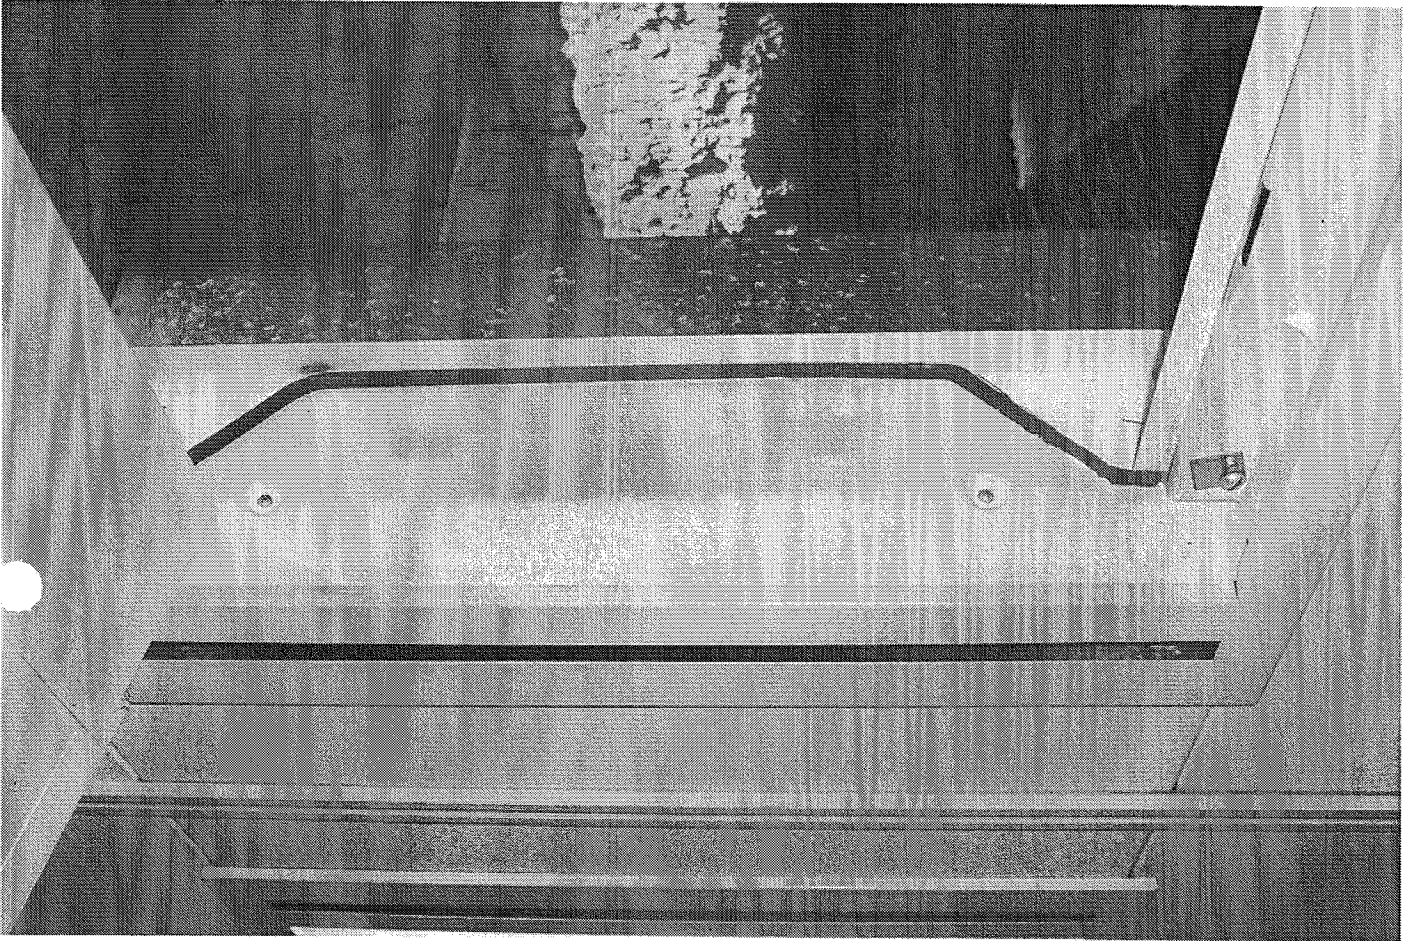
27. 21st floor, adjacent to room N2132A - View of fireproofed sprayed beam above suspended ceiling

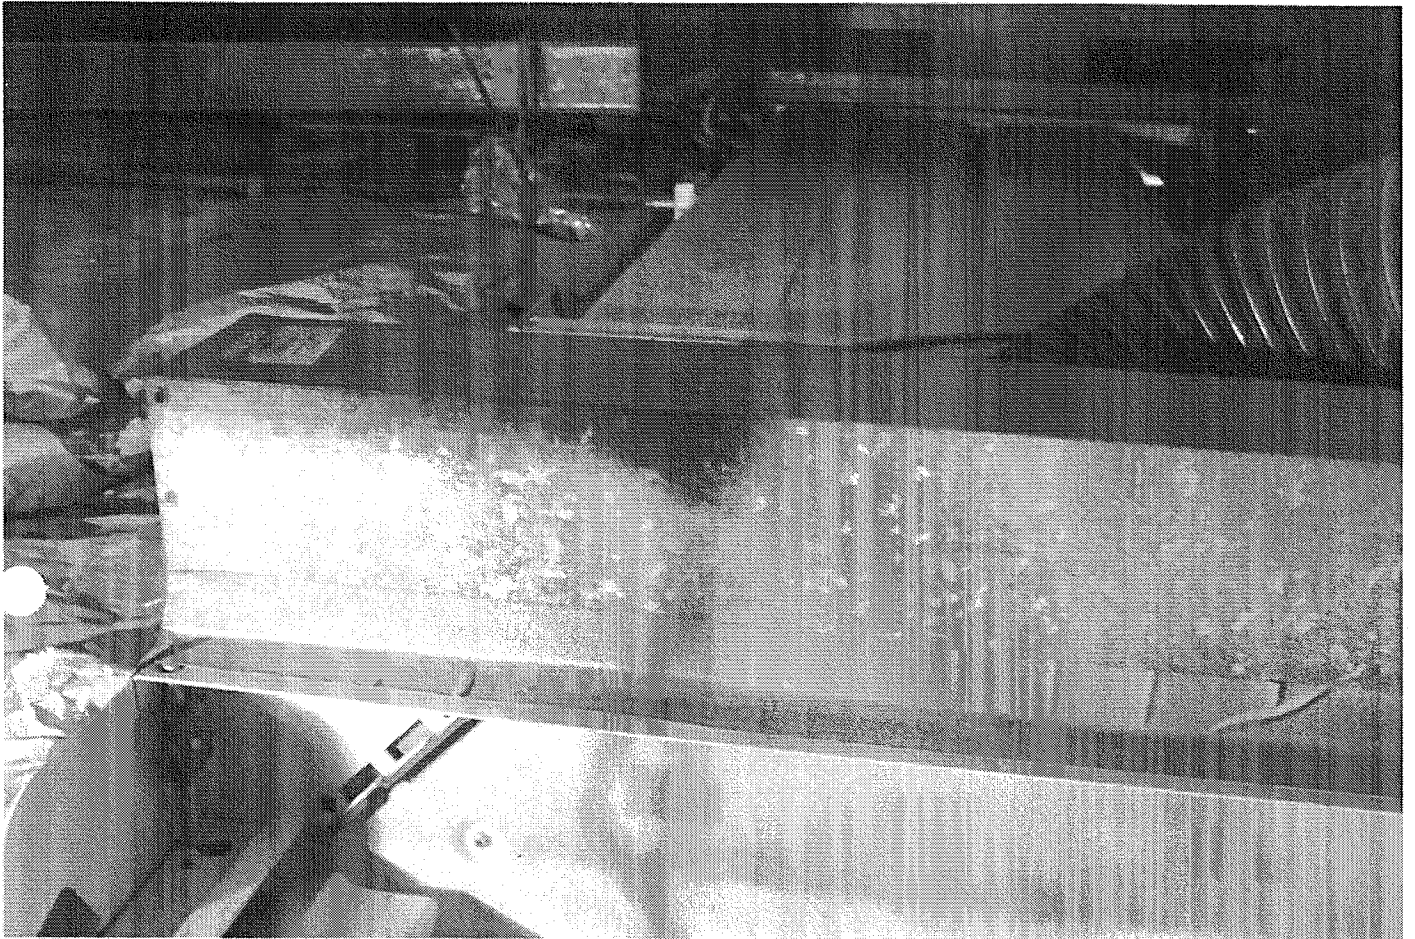
28. 21st floor, adjacent to room N2132A - Supply duct housing attached to fluorescent light fixture

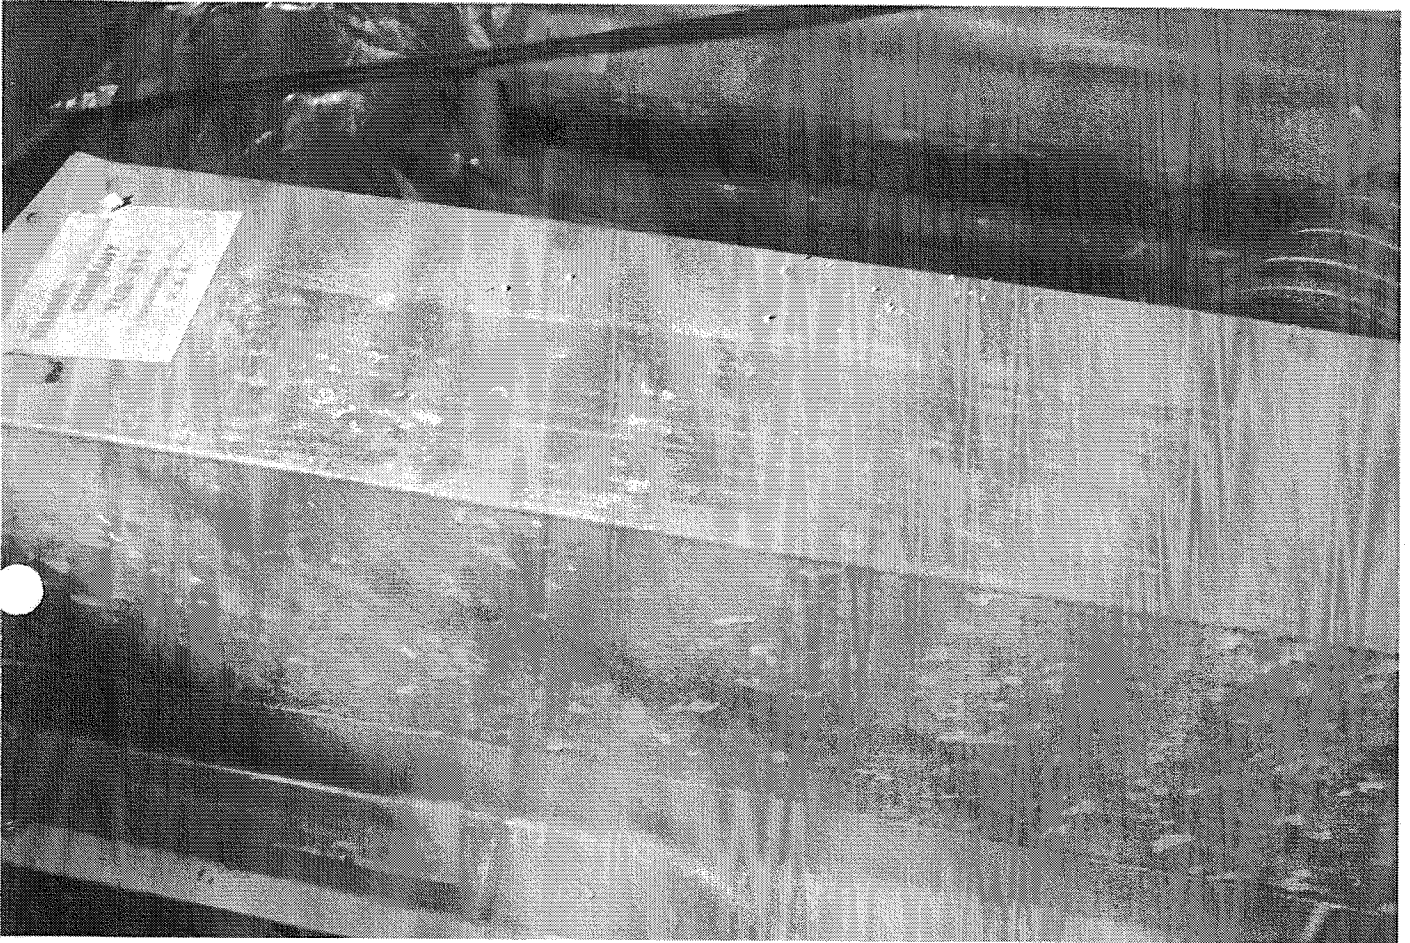
29. 21st floor, adjacent to room N2132A - Location of dust sample #2

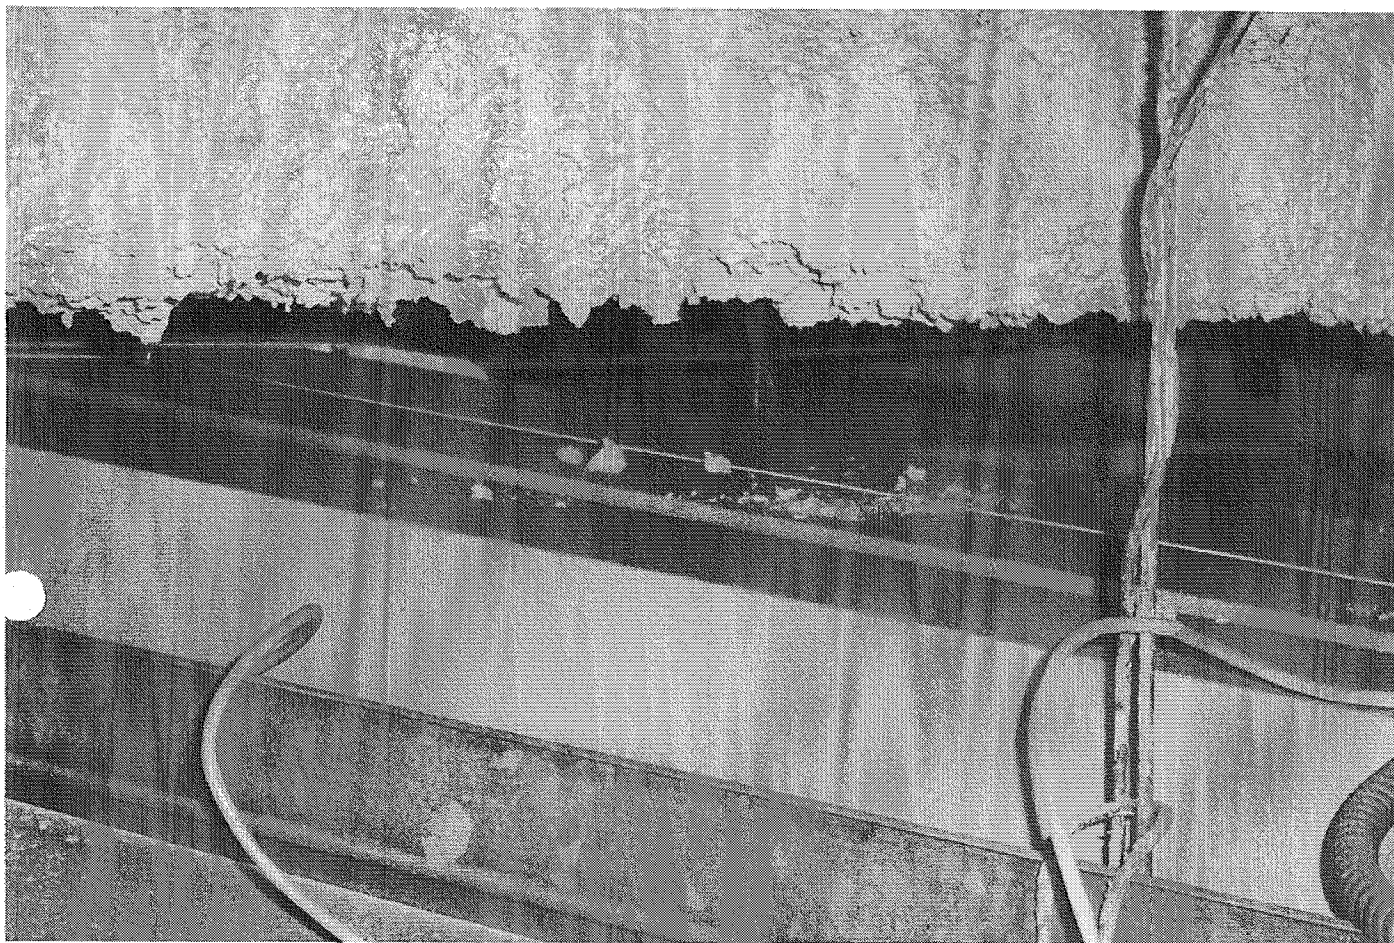
30. 21st floor, adjacent to room N2132A - View of delaminated fireproofing debris on top of fluorescent light fixture
